Manhole Inspection Summary

Manhole # S55A__010MH

Insp Date: **3/17/09 8:57 AM**

Location Address: **3801 E BALTIMORE ST**

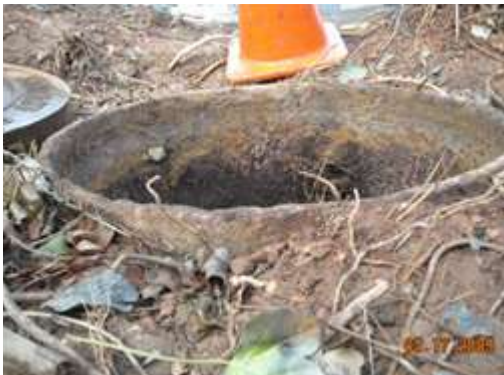
Miscellaneous

frame above grade

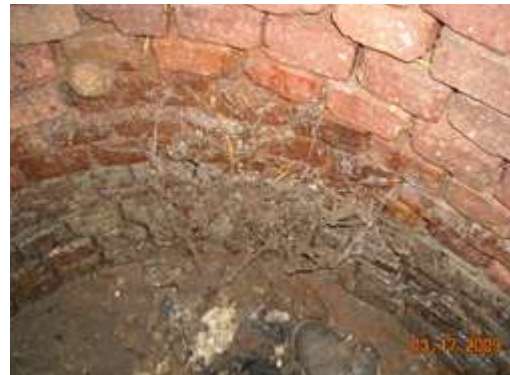
Defect 9

Infiltration: ☐ None ☐ Joint ☐ Cracks ☐ Mortar ☒ **Roots** ☒ **Wall**

root intrusion with evidence of infiltration in barrel

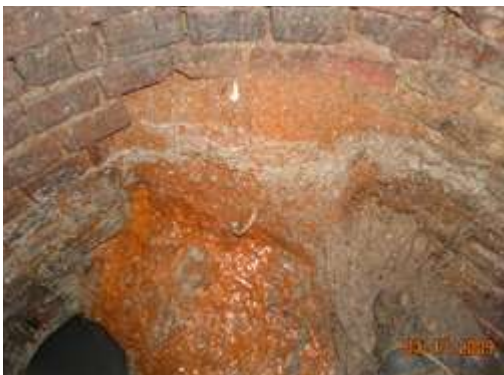
Defect 7

Condition: ☐ Sound ☐ Cracked ☒ **Root Intrusion** ☐ Loose Brick ☒ **Deteriorated**

Condition: ☐ Sound ☐ Cracked ☐ Root Intrusion ☒ **Deteriorated** ☐ Leaks ☒ **Debris**

barrel deteriorated with intrusion from wall; bench has debris & is deteriorated

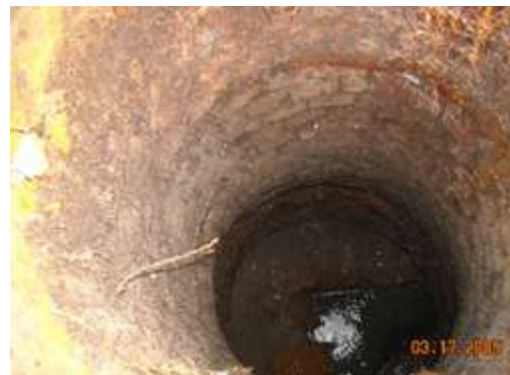
Defect 6

Steps Count: **0** Missing: **5** ☒ **Corroded**

missing/corroded steps

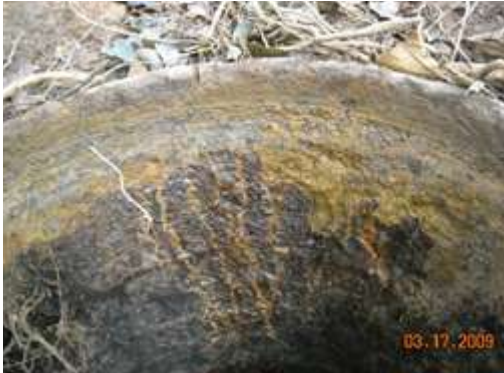
Defect 5

Frame Offset: **0** (in.) Condition: ☐ Sound ☐ Cracked ☒ **Leaks**

FRAME LEAKS

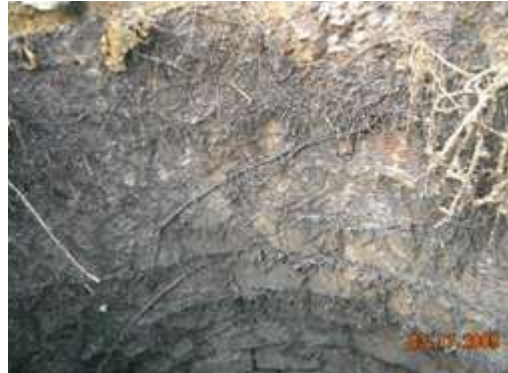
Defect 3

Condition: ☐ Sound ☐ Cracked ☒ **Root Intrusion** ☐ Loose Brick ☐ Deteriorated

ROOT INTRUSION @ CORBEL WALL;
INFILTRATION

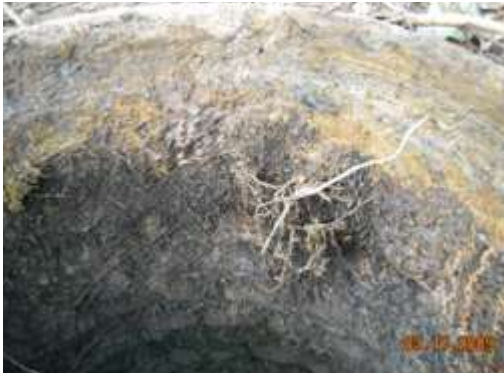
Defect 2

Condition: ☐ Sound ☐ Cracked ☒ **Root Intrusion** ☐ Loose Brick ☐ Deteriorated

ROOT INTRUSION @ CHIMNEY/FRAME
JOINT; INFILTRATION

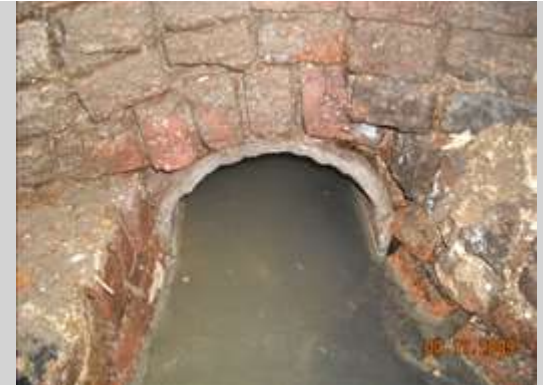
12 O'Clock Outflow

Pipe Height: **12** (in.) Rod and Bar (Angled)
Pipe Material: **Clay** ☐ Pipe Lined
Invert Depth: **11.00** (ft.) Flow Characteristics: **Fast**
Deposits: ☒ None ☐ Mud ☐ Sludge ☐ Debris ☐ Grease
Silt Depth: **0** (in.) Deposits Extent:
Infiltration: **None** Pipe Seal Cond: **Sound**

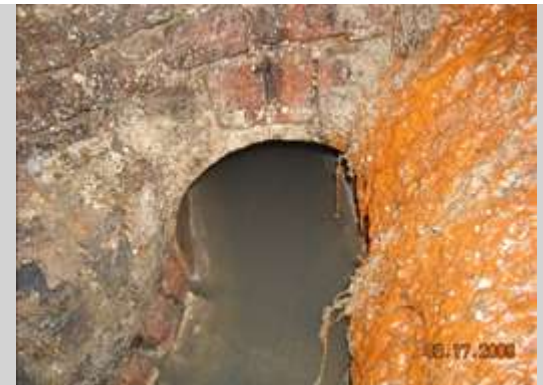
3 O'Clock Inflow

Pipe Height: **12** (in.) Rod and Bar (Angled)
Pipe Material: **Clay** ☐ Pipe Lined
Invert Depth: **10.95** (ft.) Flow Characteristics: **Fast**
Deposits: ☒ None ☐ Mud ☐ Sludge ☐ Debris ☐ Grease
Silt Depth: **0** (in.) Deposits Extent:
Infiltration: **None** Pipe Seal Cond: **Sound**
